basic imagery interpretation report

# Developments at Nenoksa and Balaklava Missile Test Centers (S)

MISSILE RANGES: NAVAL LAUNCHED FACILITIES BE: VARIOUS USSR

RCA-17/0002/83<sup>25X1</sup>
NOVEMBER 1983
Copy **3 7**

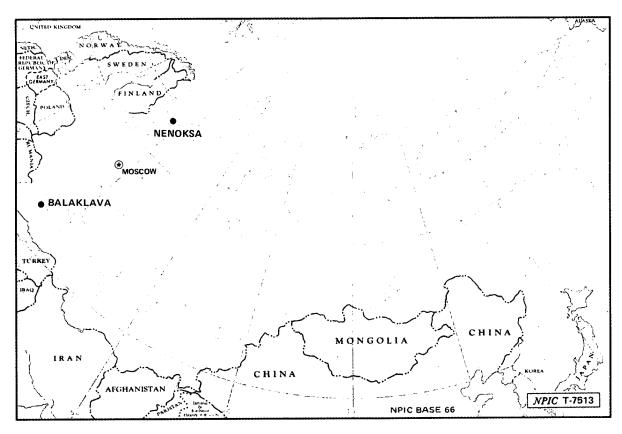
FIGURE 1. LOCATION OF NENOKSA NMTC AND BALAKLAVA MTC, USSR

4. Nenoksa NMTC, on the southern shore of the White Sea (Figure 1), is the major naval ballistic and extended-range cruise missile flight test facility in the USSR. The most recent test activity has involved the SS-NX-23 submarine-launched ballistic missile (SLBM), the probable modified SS-NX-20 SLBM, and the SS-N-12 follow-on antiship cruise missile. Land-based testing of the SS-NX-21 longrange, land-attack cruise missile, which was initiated at this facility in May 1981, has ended. (S/WN)

20. Balaklava Missile Test Center is on the coast of the Black Sea, 6 nautical miles southeast of Sevastopol (Figure 1). Static popup testing of all SLBMs and submerged-launched cruise missiles is conducted at this center. The facility has most recently been involved in the SS-NX-23 test program and the BL-10 (previously unidentified weapons system) cruise missile test program. (S/WN)
